# Portage Creek Sediment Remediation Project Kalamazoo, Michigan

Pre-Sediment Removal Structure Feature Assessment  
Removal Areas SA1-A, SA1-B and SA1-C

**FLEIS & VANDENBRINK  
ENGINEERING, INC.**

F&V Project Number: 809930  
May, 2013 (Updated June, 2013)

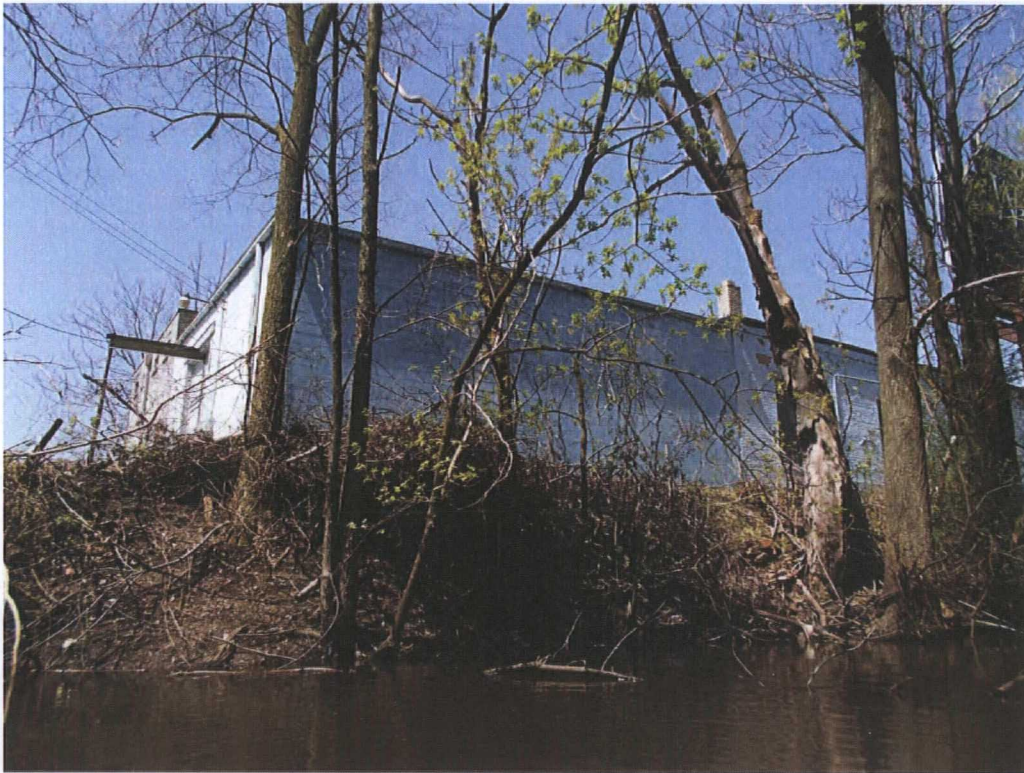
View of the south portion of the structure from the channel

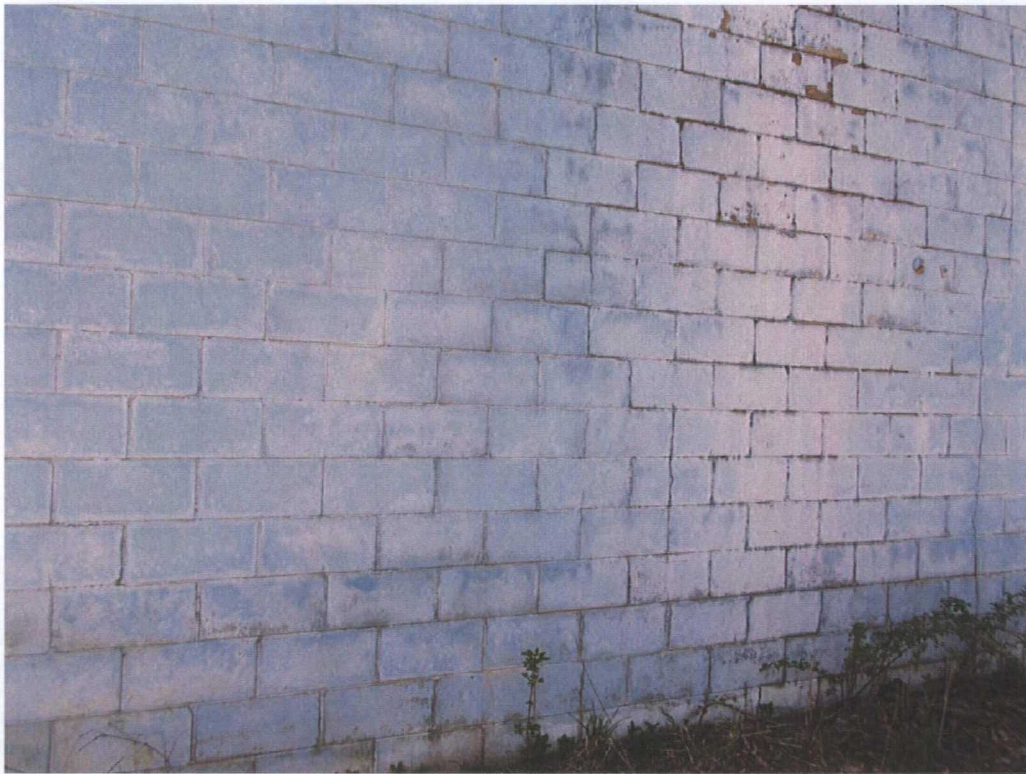
- The CMU has moderate vertical and step cracking.
- A severe vertical crack was noted at the joint between sections of the building.

Step cracking in CMU

- The building appears to be outside the influence of the sediment removal. Operators and drivers should use due care when working around the building to avoid damage from equipment.

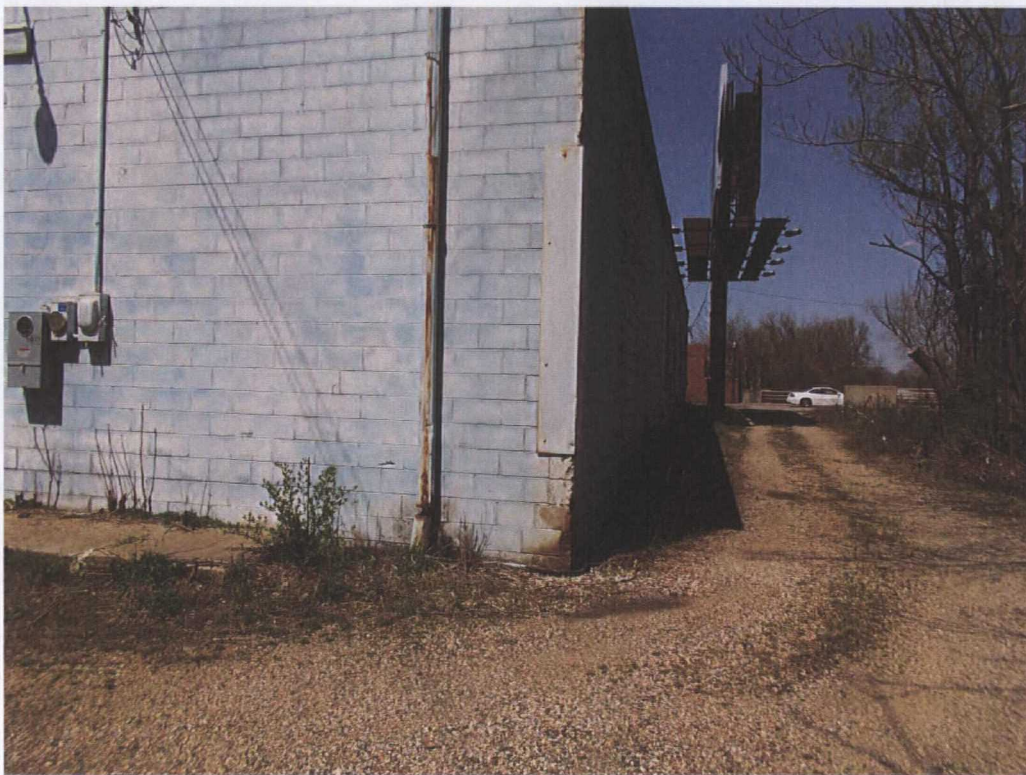
Gravel access road along the east side of the building

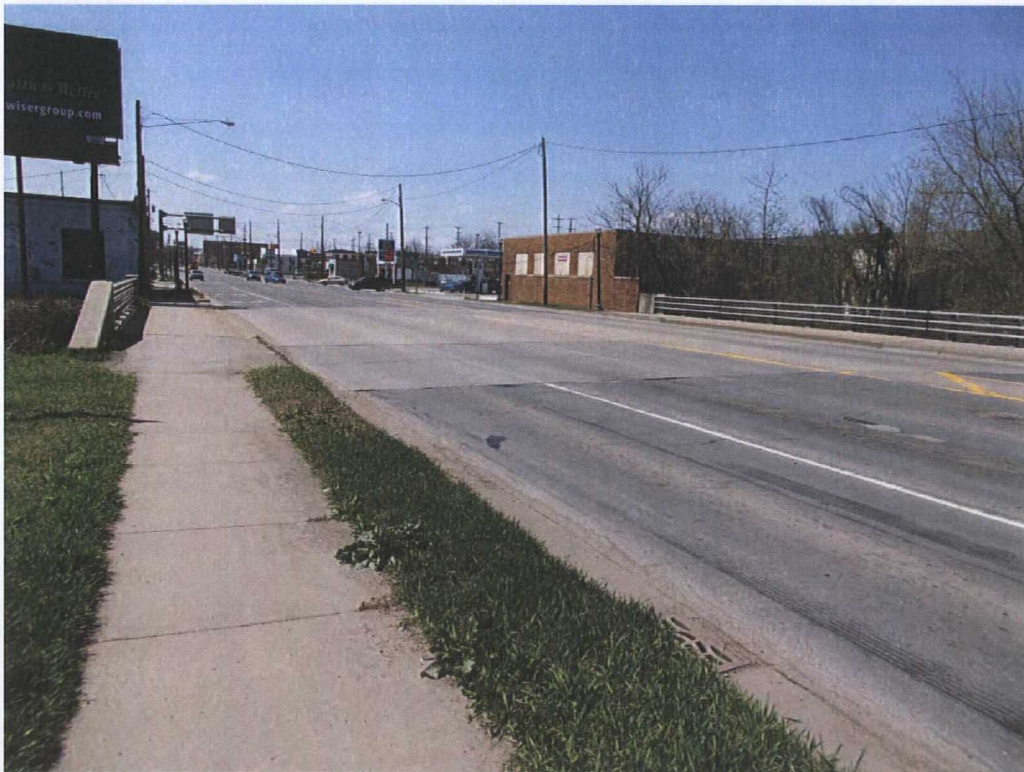
View of structure from the southeast approach area

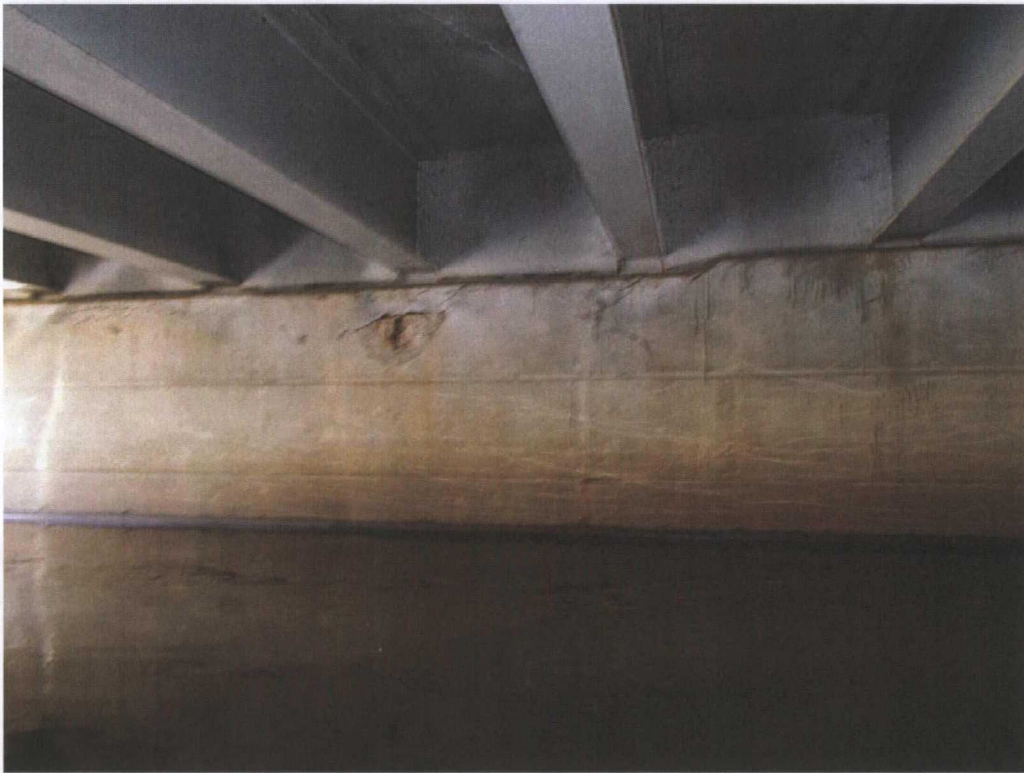
- Moderate slope/bank erosion was noted in all 4 quadrants, severe in the northwest.
- The abutments have minor to moderate vertical cracking scattered throughout. There is an isolated spall to steel beneath beam 4S on in the southwest. The top of abutment is cracked and delaminated between beams 1S and 5S in the southwest.

Spalling with exposed steel beneath beam 4S on west abutment

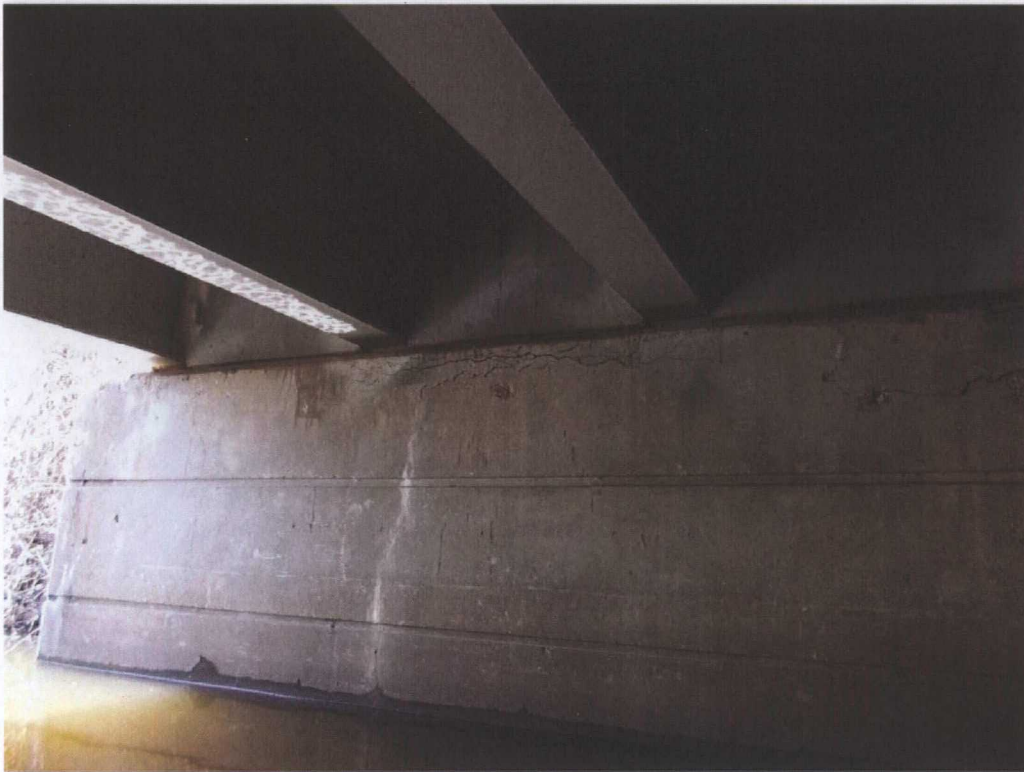
Cracking and delamination on top of abutment in southwest

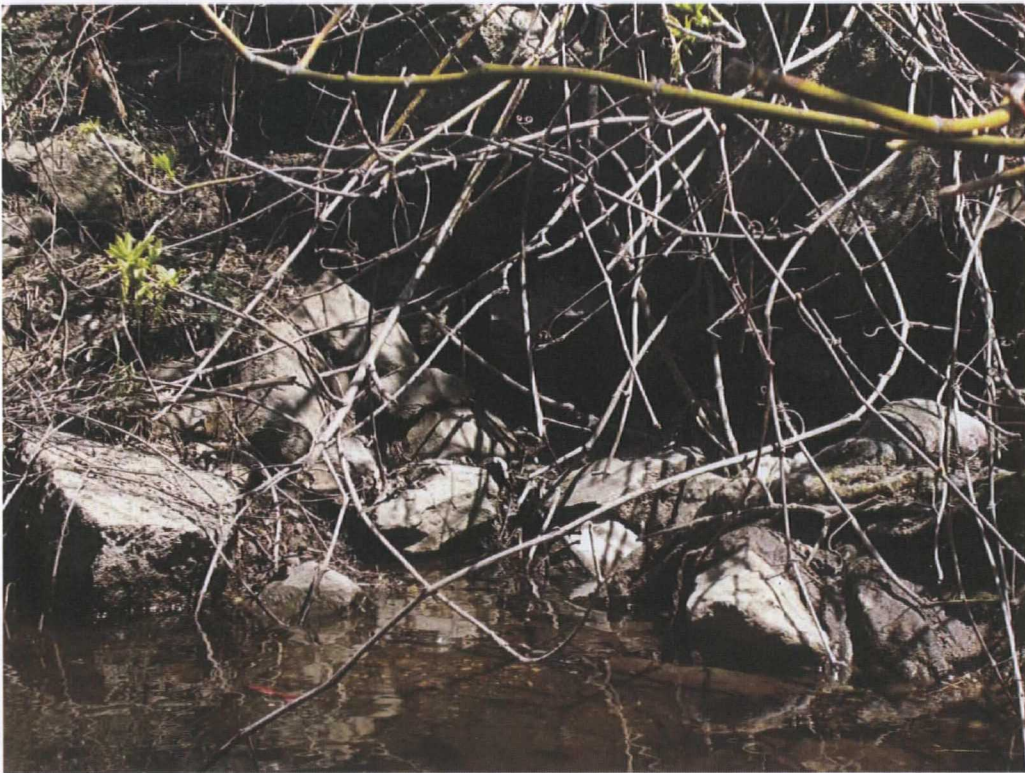
- There is a 12" concrete outlet in the southeast quadrant. The end of the pipe has severe cracking and spalling. Based on the City of Kalamazoo's mapping, there are outlets in all 4 quadrants, however, not all were located.

Concrete outlet pipe in the southeast

- The 12" storm sewer outlet in the southeast should be isolated with a cofferdam during sediment removal. A minimum clearance of 2-3' is recommended for the cofferdam. Other outlets encountered should be protected similarly.
- Because the bridge is supported on spread footings, which are more susceptible to vibration and settlement than structures on deep foundations, a minimum clearance of 6-8' is recommended for sheet pile cofferdams near the structure.
- Utilize Miss Dig Flagging to confirm the location of gas, electric, force main and water main in the area of the structure prior to installing any cofferdam structures. Maintain a minimum of 4-6 feet clearance with any sheet pile cofferdams or as directed by the utility.

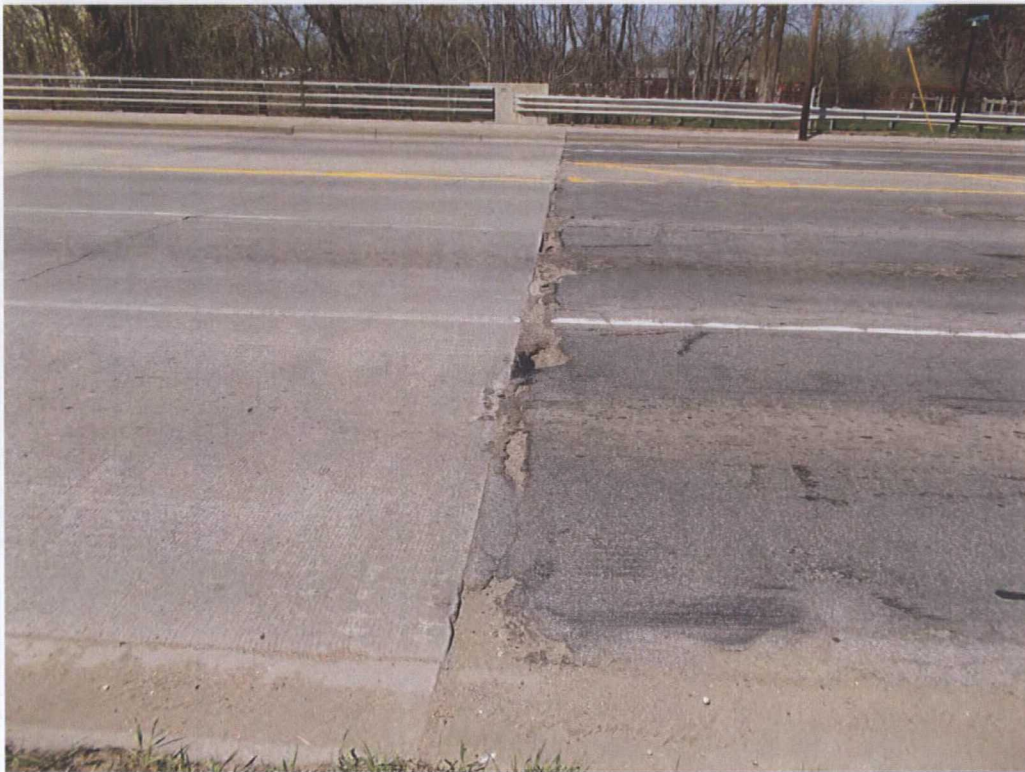
- The decorative street light in the northwest quadrant has sustained damage to its base.
- The asphalt pavement beyond the concrete approaches is severely deteriorated with significant cracking and spalling/cold patch.

Deterioration of the asphalt pavement along the east approach slab

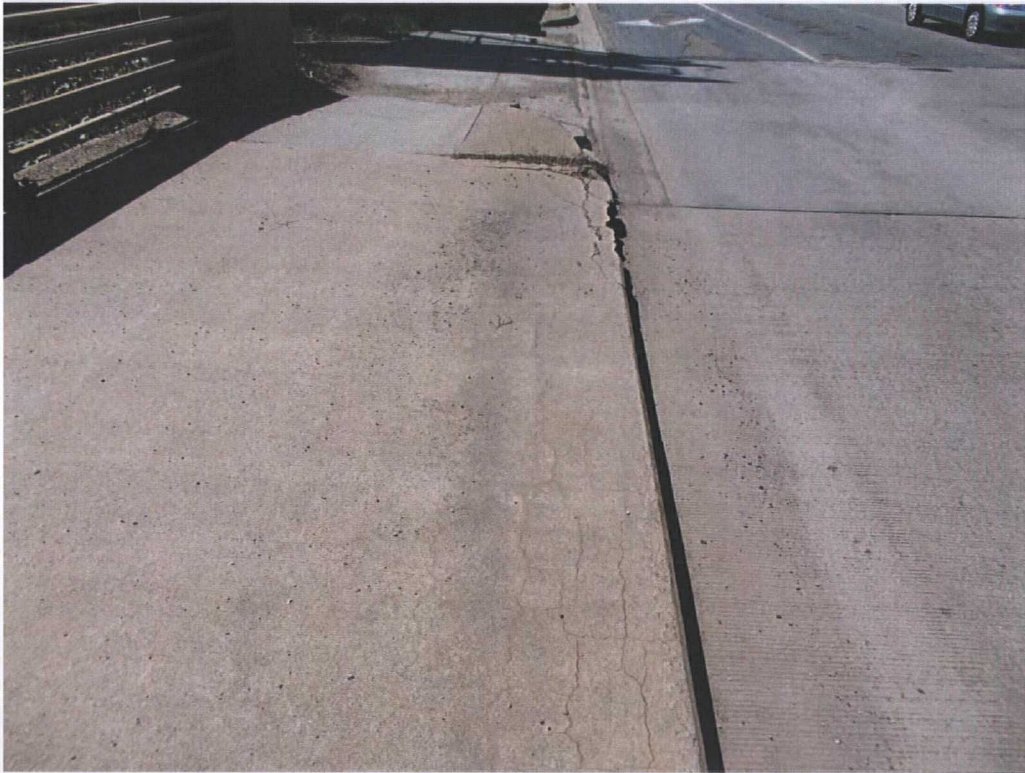
- Hairline map cracking was noted in the sidewalk beneath the railings. The sidewalks have scattered hairline to minor map cracking.
- There is an area of severe curb/sidewalk spalling in the southwest.

Cracking and spalling of southwest curb/sidewalk

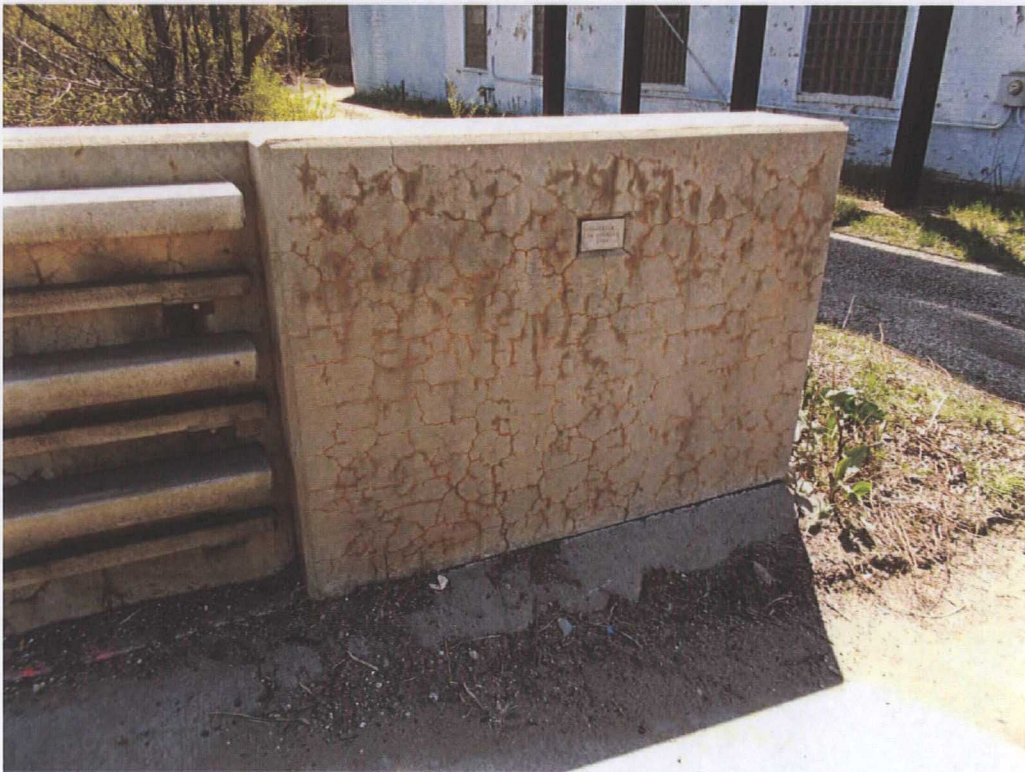
- Scattered woody debris was noted in the channel.
- The concrete approaches have severe transverse cracking.
- ASR-type cracking was noted in the railing end walls.

ASR-type cracking in the southwest end wall

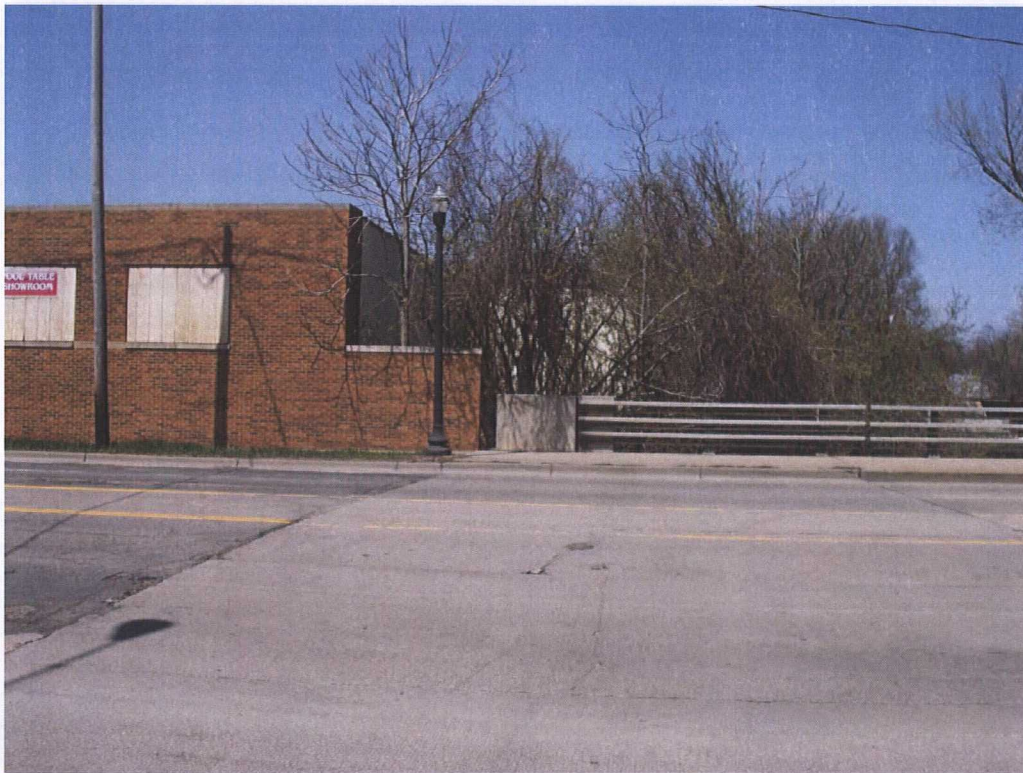
View of decorative light in the northwest

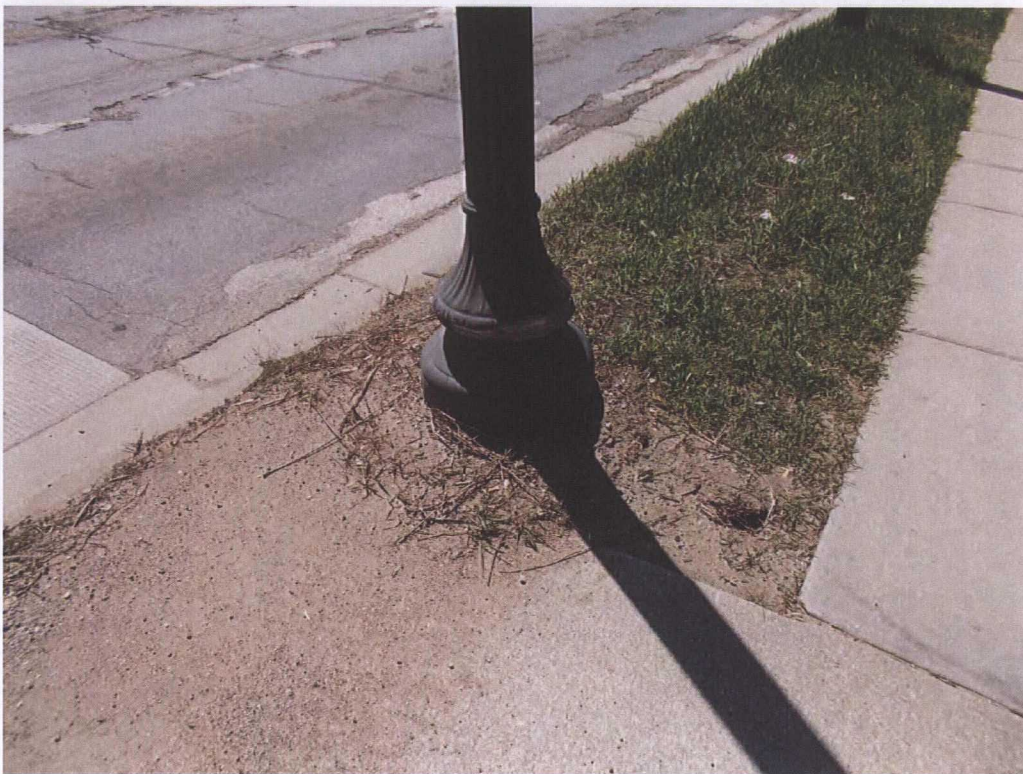
Damaged area of light base in the northwest

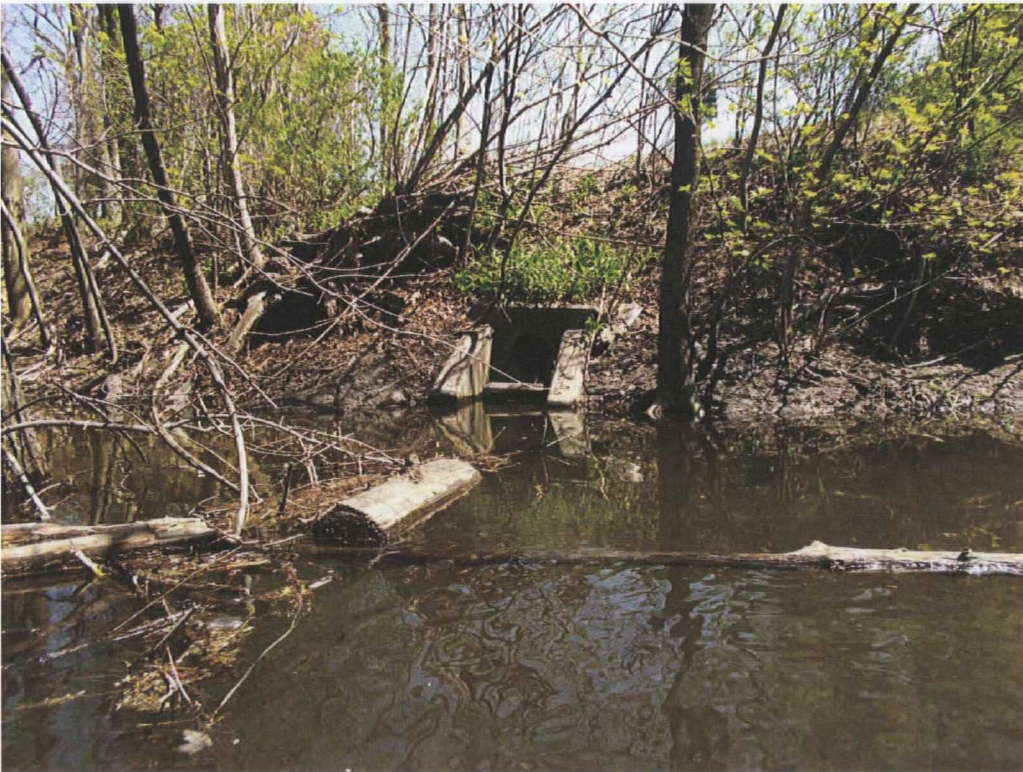
- The pipe appears to be in fair to good condition, with minor mortar cracking at the end.
- The headwall appears to be in good condition. No undermining was detected.

View of structure from the channel

- The outlet should be isolated with a cofferdam during sediment removal. A minimum clearance of 2-3' is recommended for the cofferdam.

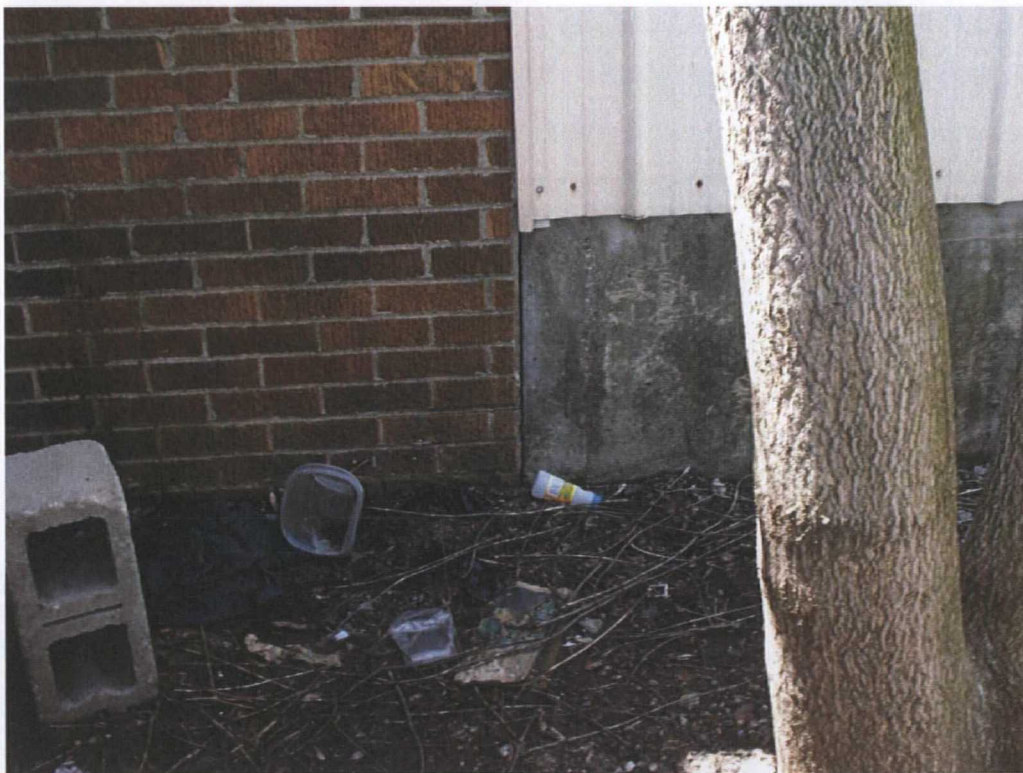
Joint separation between brick and concrete foundation wall

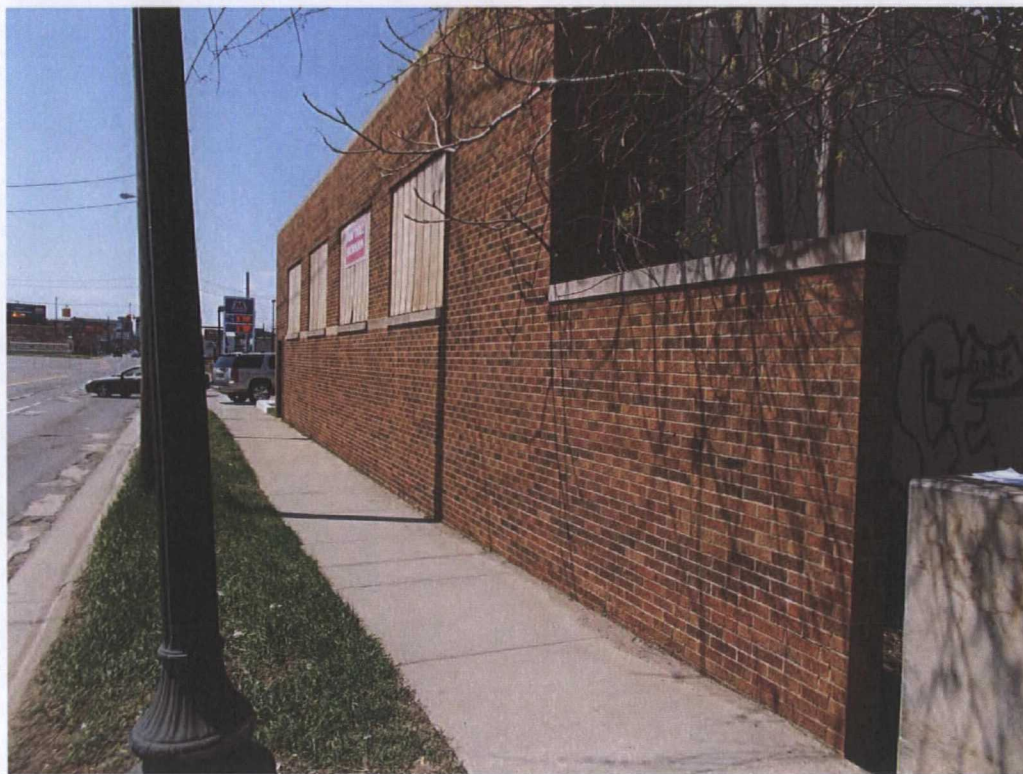
View of brick façade on south side of structure

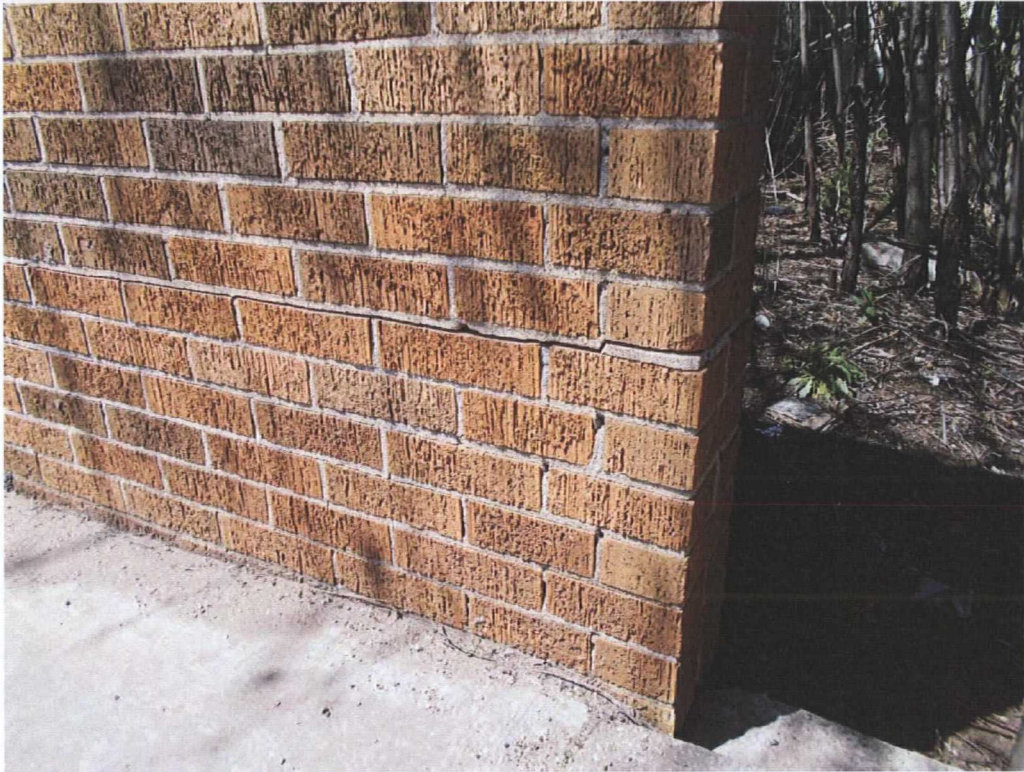
- The brick extension wall in the southeast corner has severe horizontal cracking at a mortar joint.
- The concrete foundation appears to be in fair condition.
- The aluminum siding appears to be in fair condition.
- The wood window trim is severely rotted.
- A significant amount of brush growth was noted behind the siding.
- The concrete and asphalt pavements on the north side of the building are severely deteriorated. The asphalt in particular has failed, apparently due to dumpster access.

Horizontal cracking in southeast extension wall

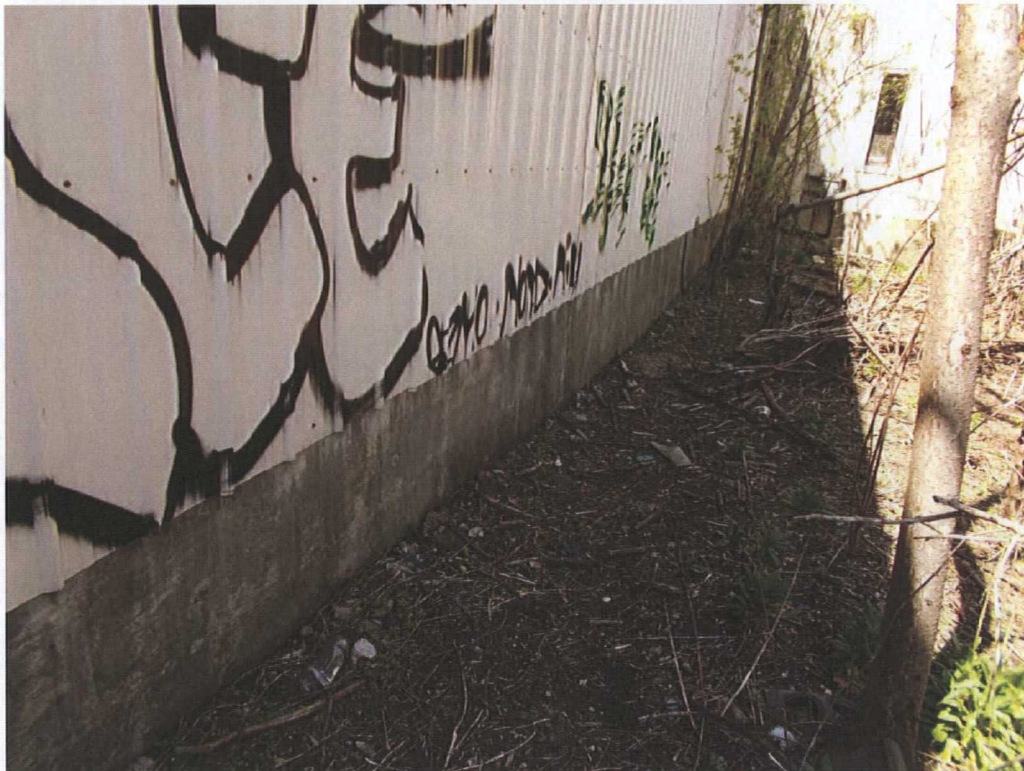
View of southeast foundation wall and siding

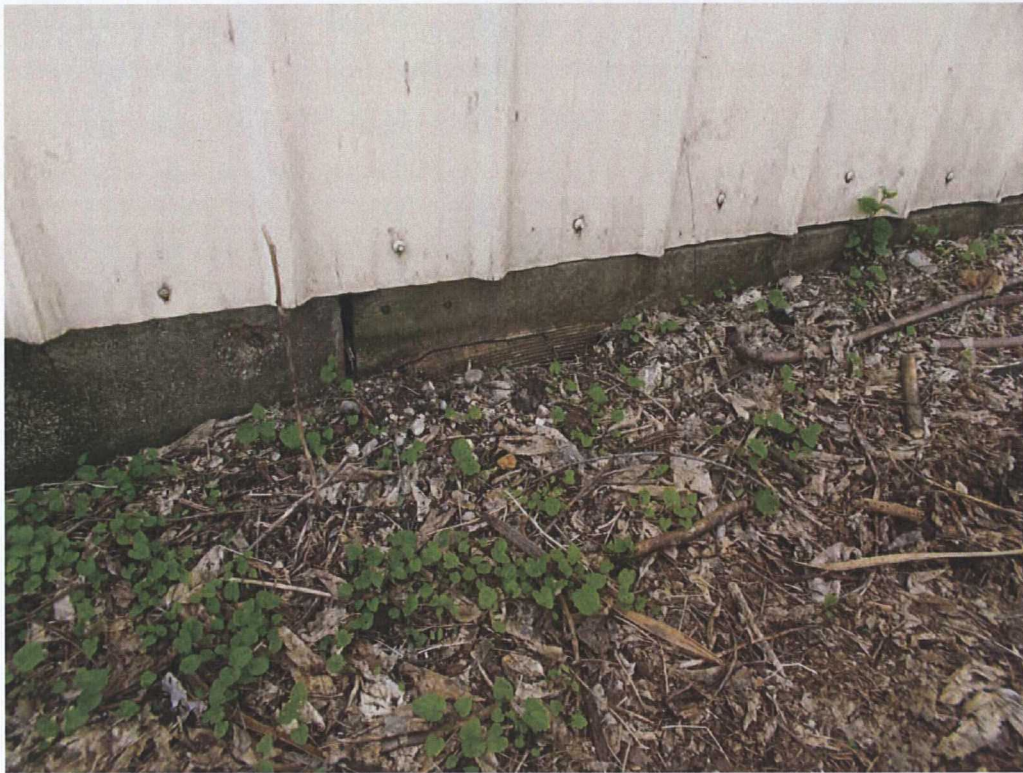
Transition between concrete foundation wall and unknown foundation

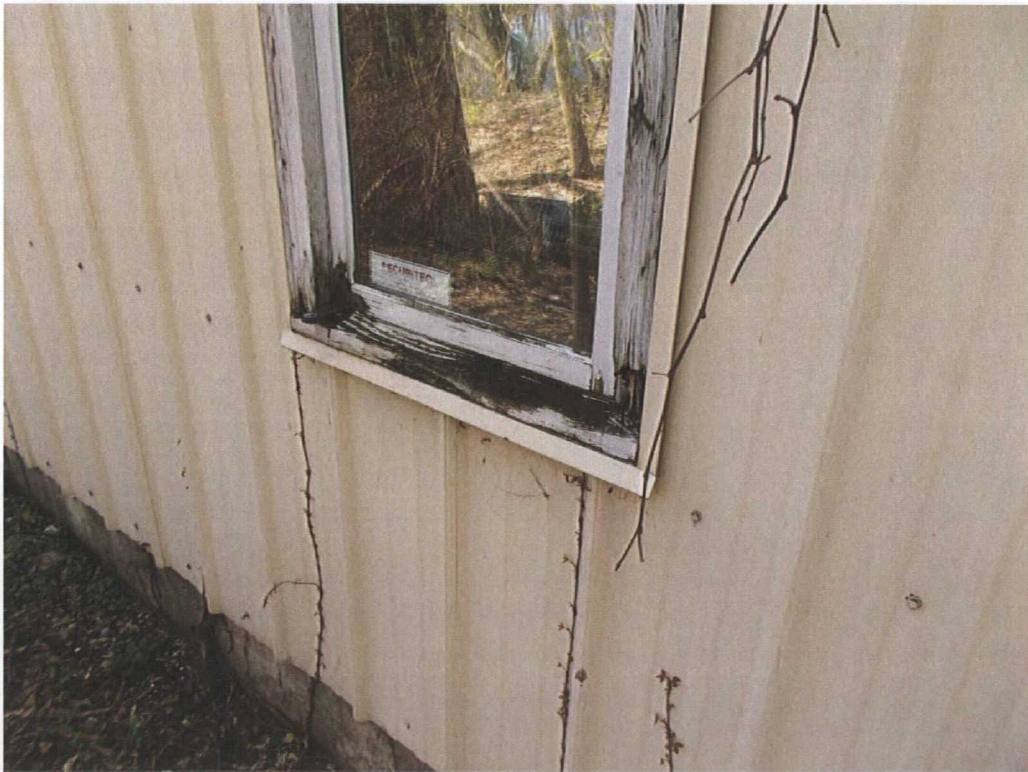
Severe rot on window trim

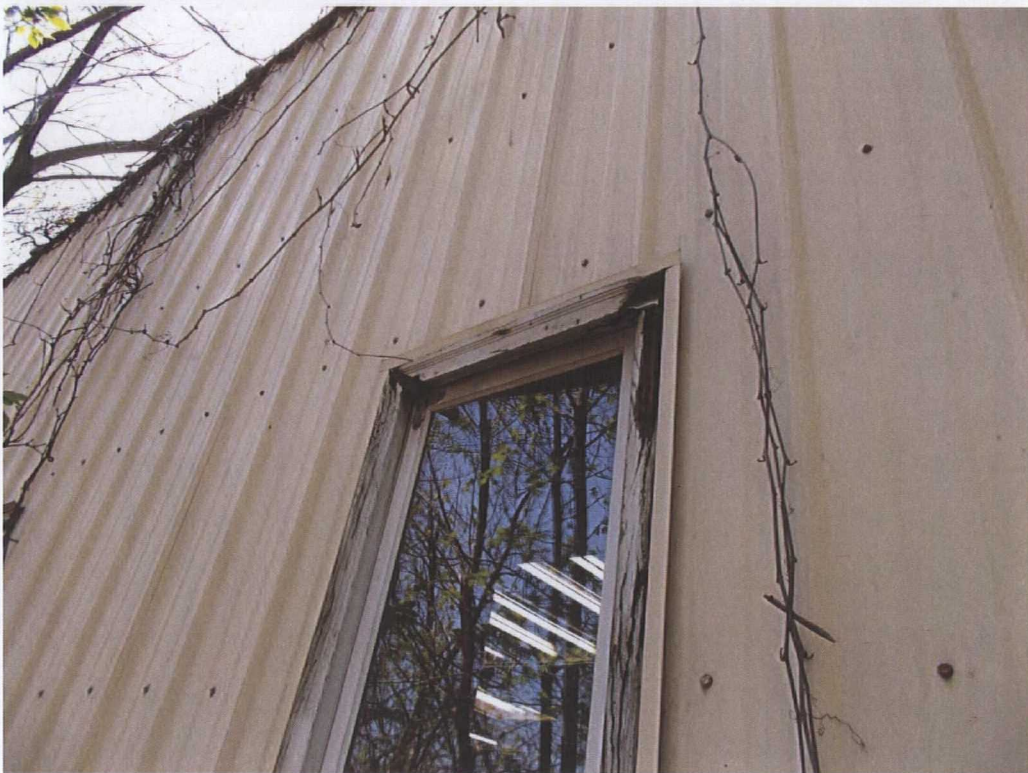
Severe rot on window trim

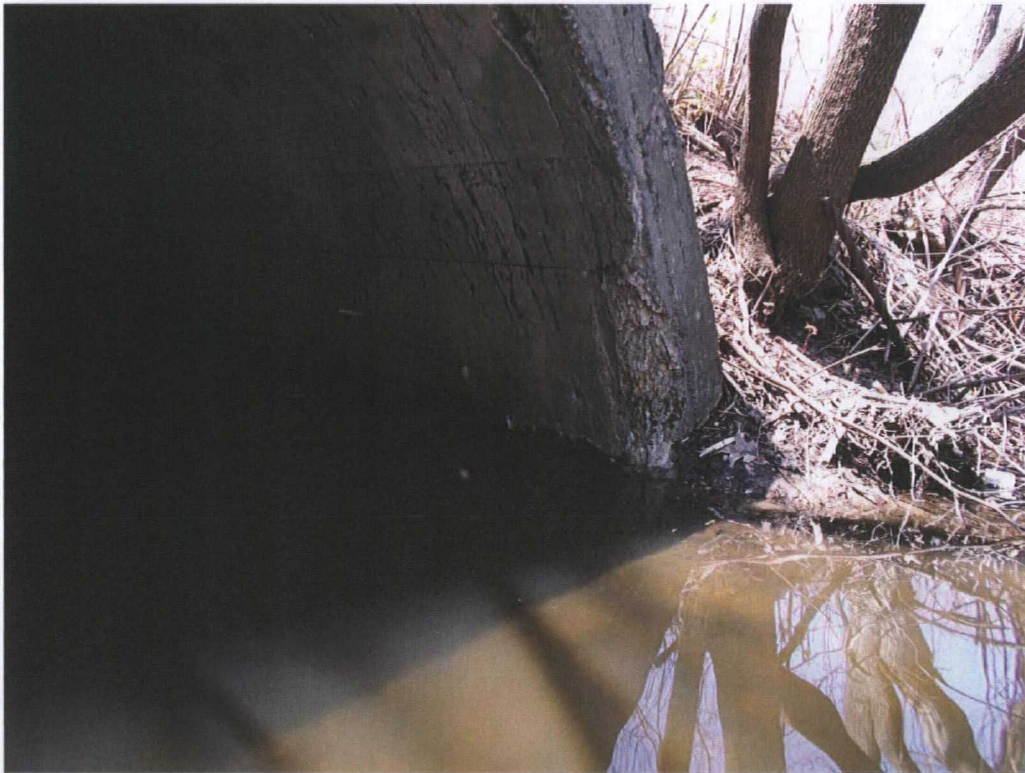
Efflorescence and delamination near the waterline

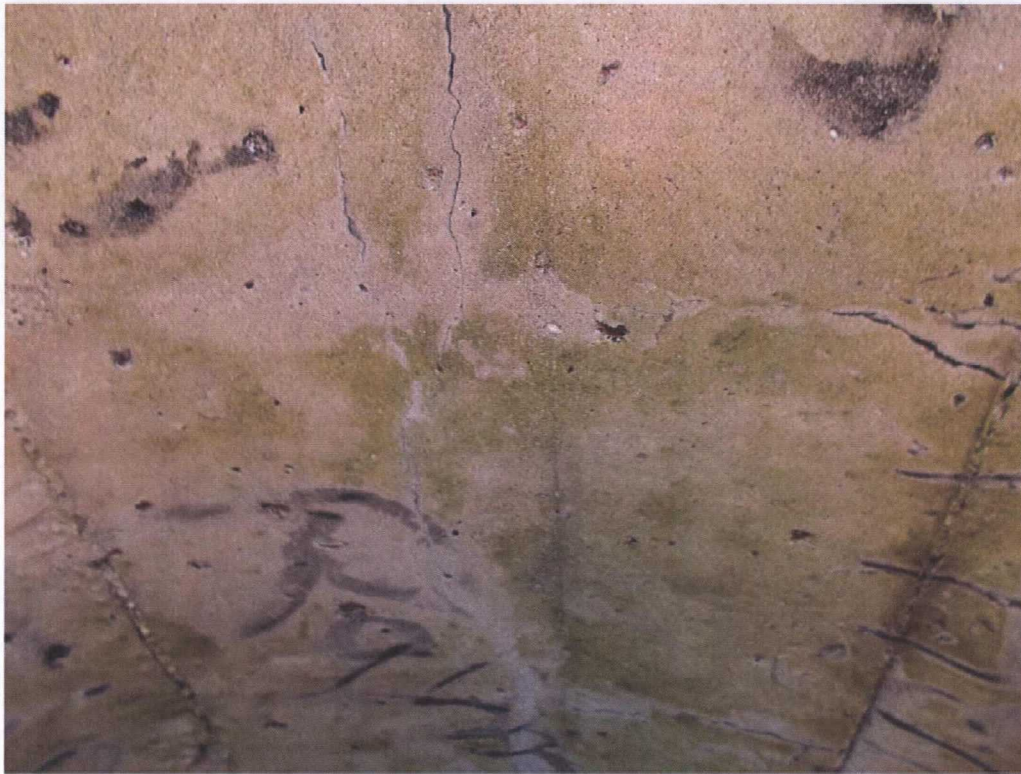
Cracking in the soffit area

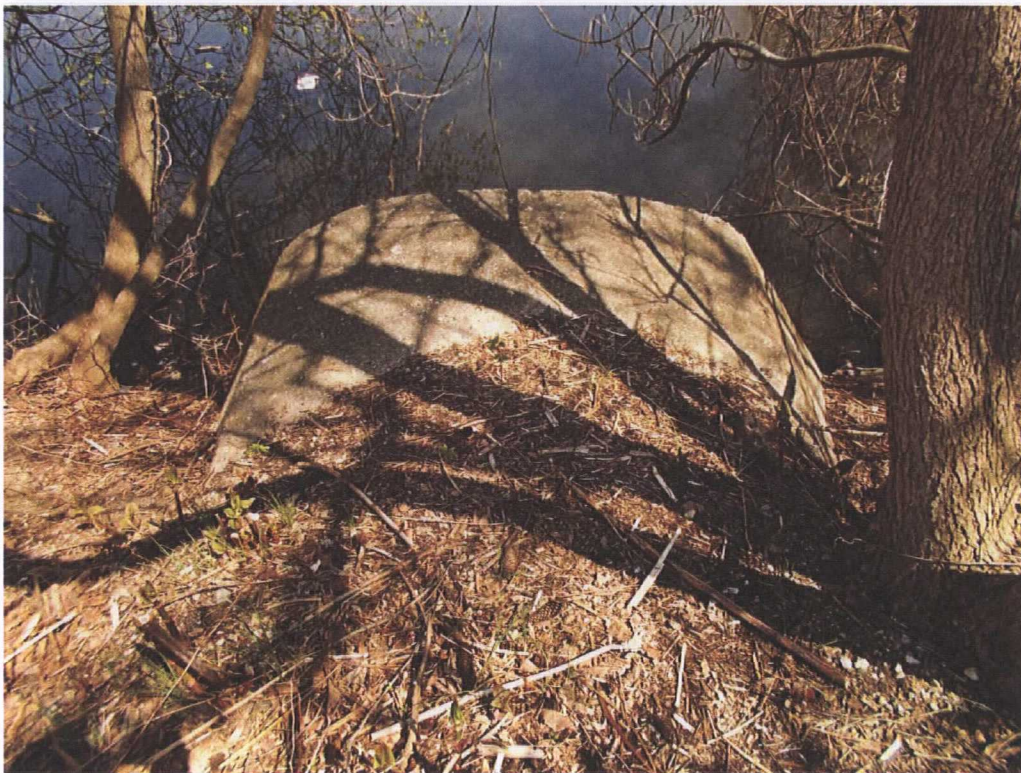
View of structure from the bank

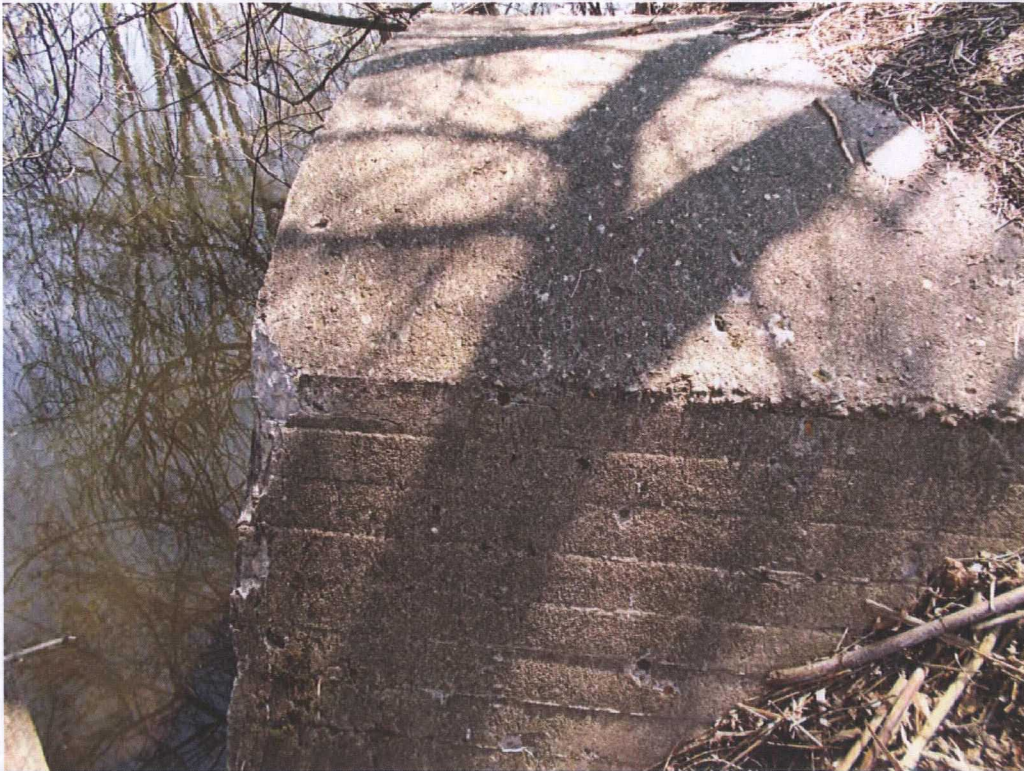
Cracking and weathering of the concrete on the northern exterior

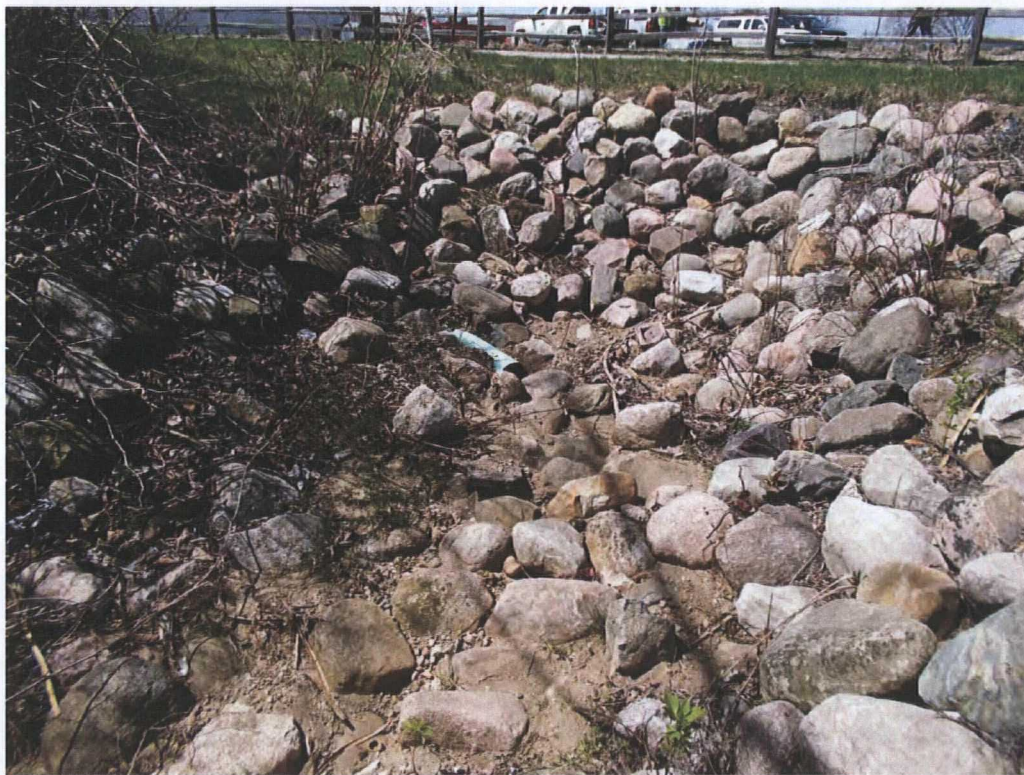
- The pipe is faded from sun exposure, but otherwise appears to be in new condition. The invert is partially buried.

View of structure from the water's edge

- The pipe itself is located back from the water's edge. Due to its limited capacity, it likely does not carry enough stormwater to warrant isolation. It should be protected from inadvertent damage during sediment removal.
- Field stone should be removed and replaced as required during sediment removal. It should be replaced on a geotextile liner to prevent erosion of the underlying soils.

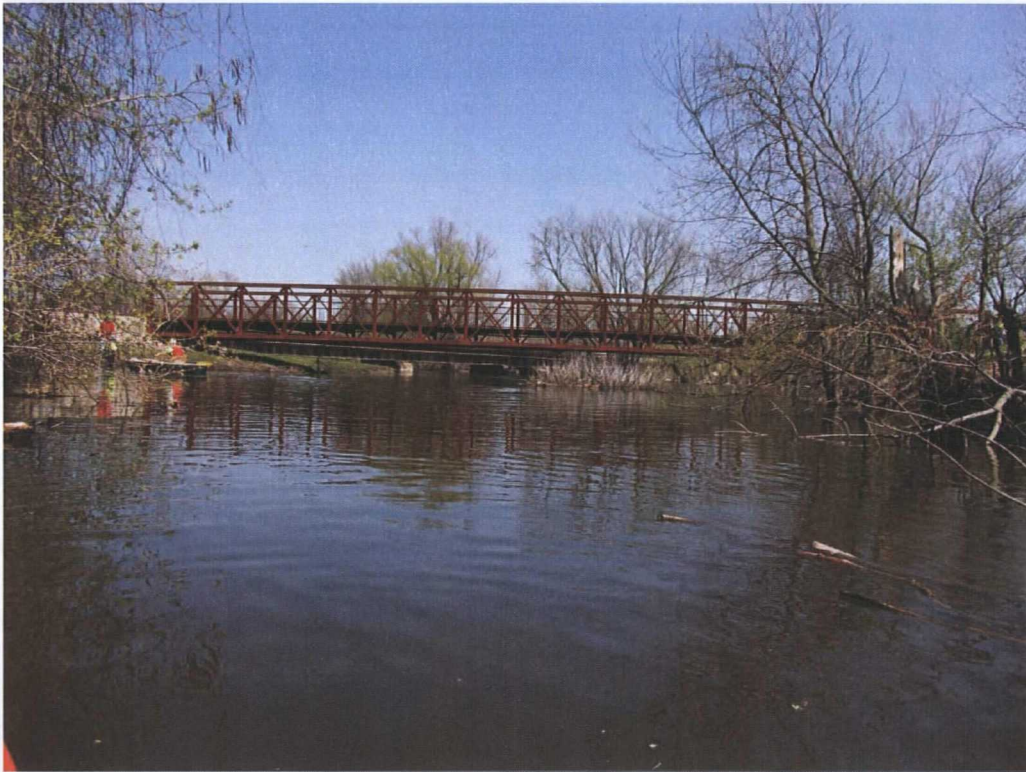
Elevation view of structure from the upstream channel

- Because the west abutment is on a deep foundation, it is less susceptible to vibrations than one on shallow foundation. A minimum of 3-4 feet clearance is recommended between sheet pile cofferdam structures and the abutment.
- Due to its unknown support configuration, additional care should be used when working around the east abutment. A minimum clearance of 6-8' is recommended for sheet pile cofferdams in the area. It may be effective to infill between the abutment and end of sheet pile with sand bags or other shallow cofferdam measures.
- Maintain a minimum of 4-6' clearance between the sanitary force main and sheet pile cofferdams, or as directed by the City of Kalamazoo. If sediment removal is required in closer proximity, the force main should be hand exposed first to confirm its exact depth and location.

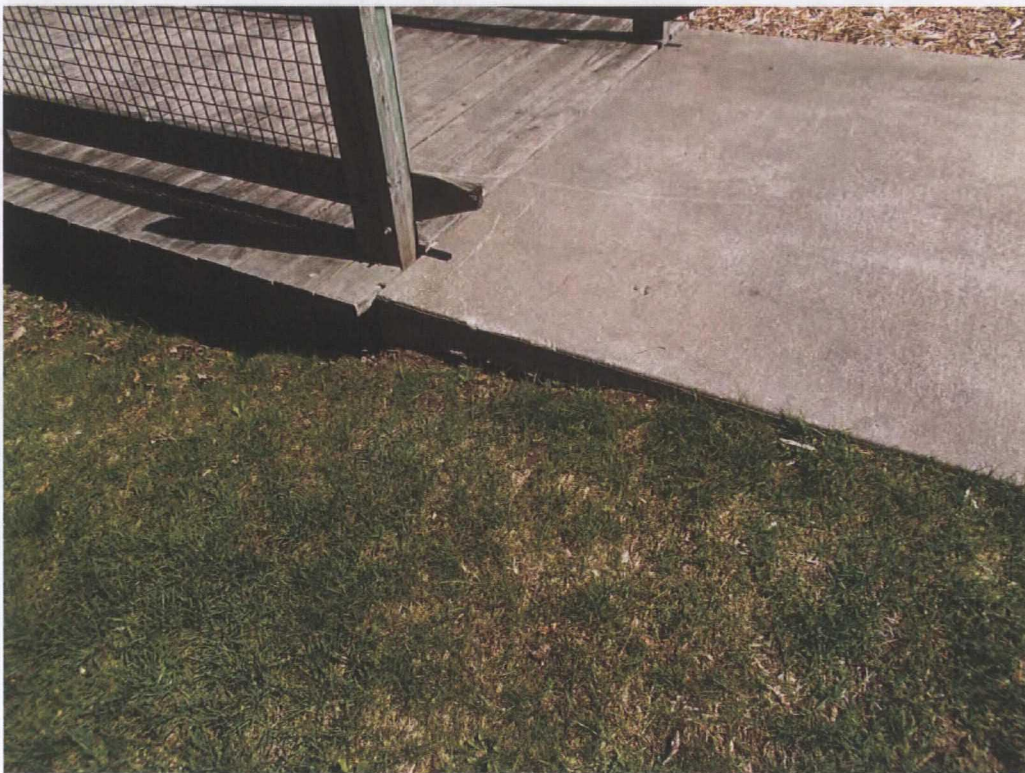
- The timber decking is weathered and has minor splitting over most of its area.
- Field stone riprap is in place around both abutments.
- The concrete sidewalk connecting to the boardwalk in the southeast is undermined approximately 2" and has cracking near its end.

Undermined and cracked concrete sidewalk in the southeast
